Aviation Safety

Maintainer

Issue 1/2000

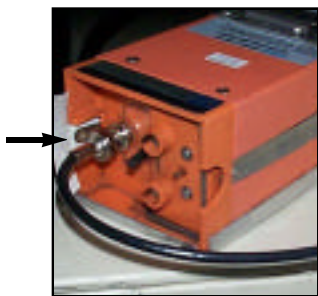
A recent ramp check of a Bell 206 revealed that the Narco 10 emergency locator transmitter (ELT) installed in the cabin would not be able to transmit a signal strong enough to be received by Search and Rescue Satellite Aided Tracking (SARSAT) or another aircraft.

The problem was that the ELT had two antennae connected at the same time. The external antenna was connected to the coax connector and the integral (portable) antenna was touching the finger tab protruding from the top of the ELT. On this installation there was no insulating tab installed to disconnect the portable antenna.

The ELT in the photograph has already had its T-handle reversed to insulate the portable antenna from the transmitter (arrow).

If either of these conditions exist, the integral antenna will remain connected and will draw a significant portion of the output power, thus resulting in degraded performance from the fixed antenna. This would not be detected by the ELT functional test, as the ELT antennae are sufficiently close to the aircraft VHF communications antenna that even a very low power output will be picked up by the VHF receiver."

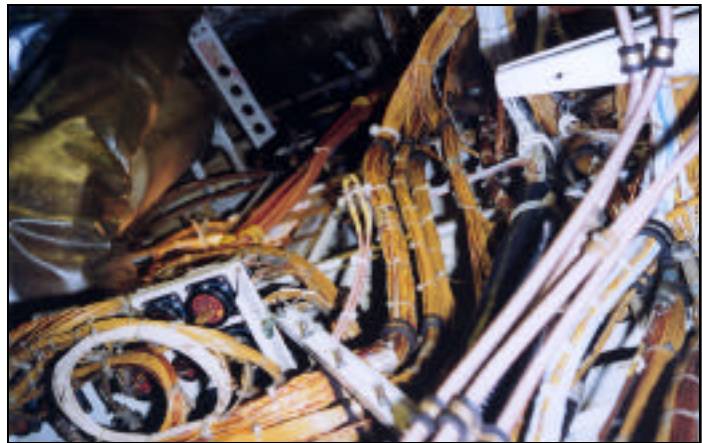
How many faults can you locate?

Airworthiness directives about wires rubbing on the rivet heads on the underside of the wire loom have been issued. A thorough inspection of the cable is necessary. Look at the support of the cables, their routing, and their relationship to the surrounding aircraft structure.
